**Flood Control Project Maintenance
Levee Inspections****LMA District Cover Sheet****Spring 2012 Levee Inspection Results****Butte County Public Works Department Butte County Public Works**

Spring 2012 Levee Inspection Results

Waterway			Bank	Unit Miles
Unit No. 01 Mud Creek			Right	7.29
	Spring (March - May)	Summer (June - August)	(September - November) Fall	Winter (December - February)
Unit Maintenance Rating (Fall Only)				
Date of Inspection	4/4/2012 - 4/4/2012			
DWR Inspector	Bob Duffey			
Accompanied By	Dave Herfi Butte Co.

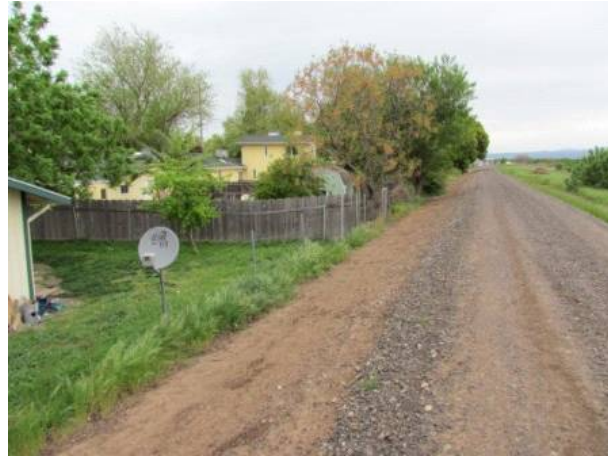
Levee Mile Report Line	4
Start Levee Mile	2.06
End Levee Mile	2.10
Location	Land Side
Category	Earthen Levee
Item	Encroachments

View of the fences along the L/S toe.

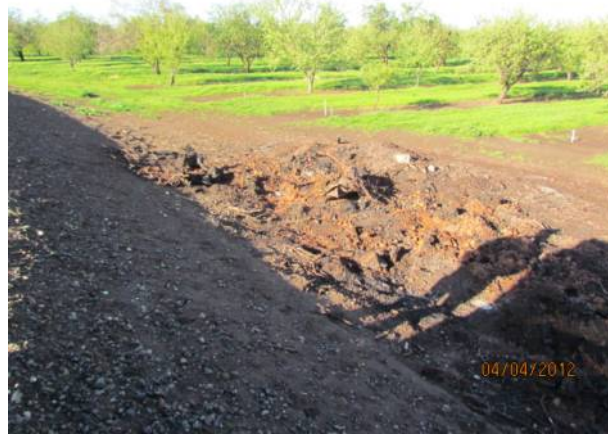
Levee Mile Report Line	7
Start Levee Mile	2.65
End Levee Mile	2.65
Location	Land Side
Category	Earthen Levee
Item	Encroachments

The pruning have been removed from the toe of the levee.

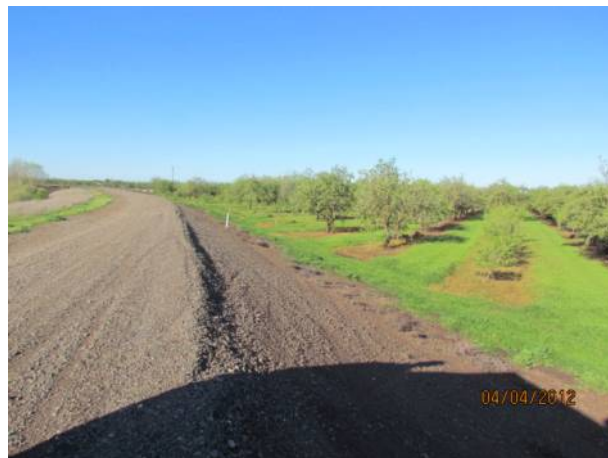
Levee Mile Report Line	8
Start Levee Mile	2.90
End Levee Mile	2.90
Location	Land Side
Category	Earthen Levee
Item	Animal Control

The rodent holes have been grouted by Butte County.

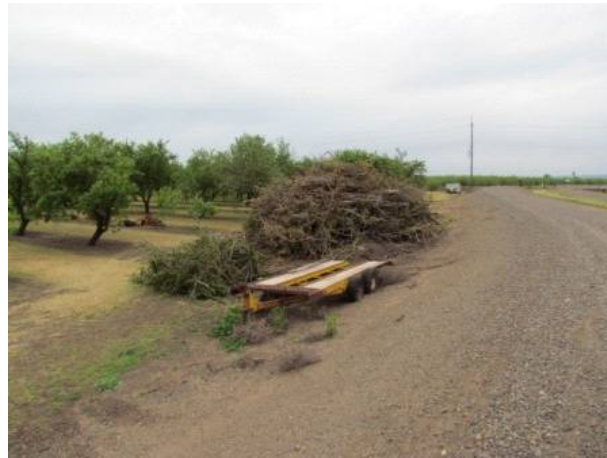
Levee Mile Report Line	9
Start Levee Mile	3.00
End Levee Mile	3.00
Location	Land Side
Category	Earthen Levee
Item	Encroachments

View of the pruning pile along the L/S toe.

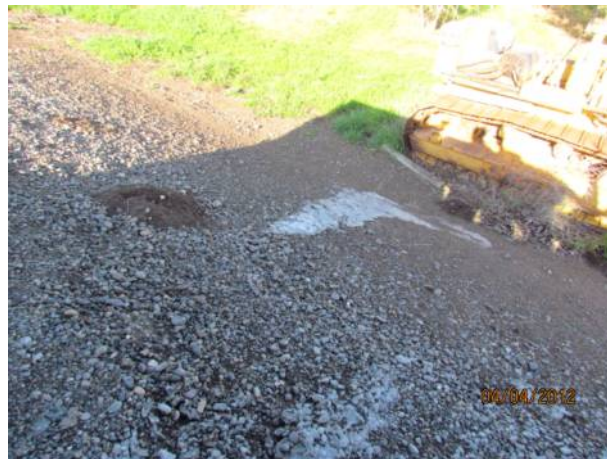
Levee Mile Report Line	11
Start Levee Mile	3.22
End Levee Mile	3.22
Location	Land Side
Category	Earthen Levee
Item	Animal Control

DWR ID: DWR_NA0003_01_s_2012_25											
11	3.22	3.22	Earthen Levee	Animal Control	LS	A Ma	A3 : No rodents visible, but rodent burrows visible; need to backfill and compact or grout burrows. Inspector Comments: The rodent holes have been filled with grout.	39.762548 ° -121.909872 °	39.762547 ° -121.909868 °	6 Y	
DWR ID: DWR_NA0003_01_s_2012_6											
12	3.33	3.33	Earthen Levee	Animal Control	LS	A Ma	A3 : No rodents visible, but rodent burrows visible; need to backfill and compact or grout burrows. Inspector Comments: The rodent hole have been filled with grout.	39.764123 ° -121.908970 °	39.764123 ° -121.908970 °	12 Y	
DWR ID: DWR_NA0003_01_s_2012_12											
13	3.98	3.98	Earthen Levee	Encroachments	LS	M Ma	PR : Prunings	39.770351 ° -121.901349 °	39.770351 ° -121.901349 °	5	
DWR ID: DWR_NA0003_01_s_2012_5

The rodent holes have been grouted by Butte County.

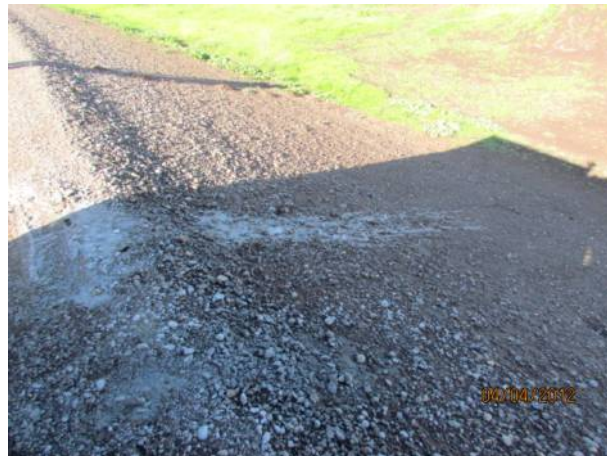
Levee Mile Report Line	12
Start Levee Mile	3.33
End Levee Mile	3.33
Location	Land Side
Category	Earthen Levee
Item	Animal Control

The rodent holes have been grouted by Butte County.

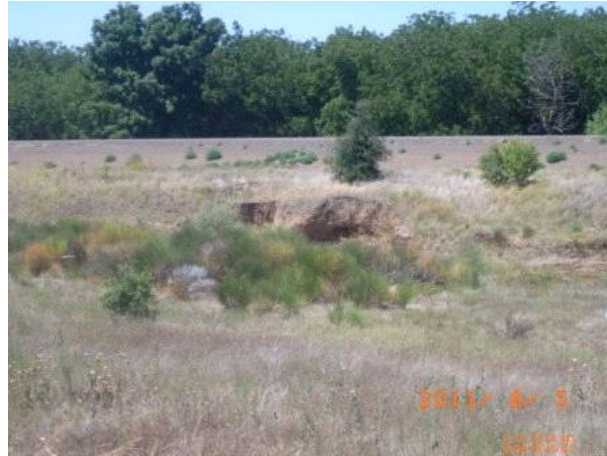
Levee Mile Report Line	14
Start Levee Mile	4.22
End Levee Mile	4.22
Location	Water Side
Category	Supplemental
Item	USACE Erosion Survey

LMR No.	Levee Mile		Category	Item	* Location	+ Rating	Action/Comment	GPS Latitude/Longitude		Issue No. Photo
	Start	End						Start	End	
14	4.22	4.22	Supplemental	USACE Erosion Survey	WS	M Ma	Inspector Comments: 2011: Two large erosion scallops at the toe from a rotational failure. Deep cracks along the slope indicate the potential for further failures. [2011 Site ID: MUD_4-4_R]	39.773257 ° -121.895618 °	39.773969 ° -121.895078 °	13 Y
DWR ID: DWR_NA0003_01_s_2012_13										
15	4.58	4.58	Earthen Levee	Encroachments	LS	M Ma	PR : Prunings	39.775908 ° -121.893947 °	39.775908 ° -121.893947 °	21
DWR ID: DWR_NA0003_01_s_2012_21										
16	4.92	4.92	Earthen Levee	Animal Control	LS	C Ma	A3 : No rodents visible, but rodent burrows visible; need to backfill and compact or grout burrows.	39.780170 ° -121.891352 °	39.780170 ° -121.891352 °	8
DWR ID: DWR_NA0003_01_s_2012_8

USACE 2011 Photo #1

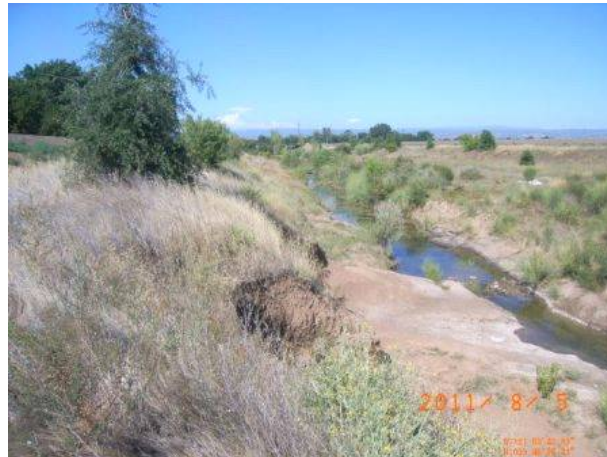
Levee Mile Report Line	14
Start Levee Mile	4.22
End Levee Mile	4.22
Location	Water Side
Category	Supplemental
Item	USACE Erosion Survey

USACE 2011 Photo #2

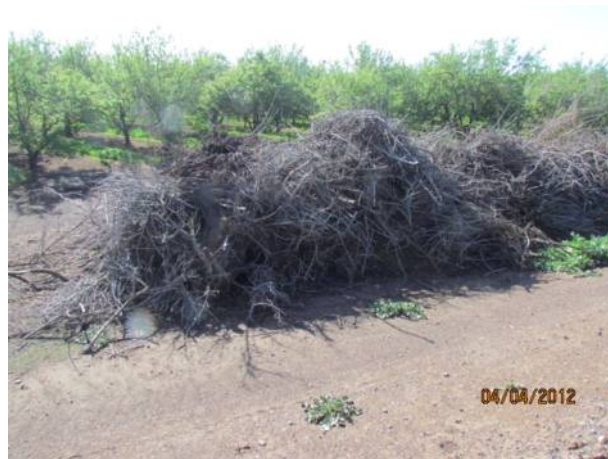
Levee Mile Report Line	2
Start Levee Mile	4.70
End Levee Mile	4.70
Location	Land Side
Category	Earthen Levee
Item	Encroachments

View of the tree prunings at the toe of the levee.

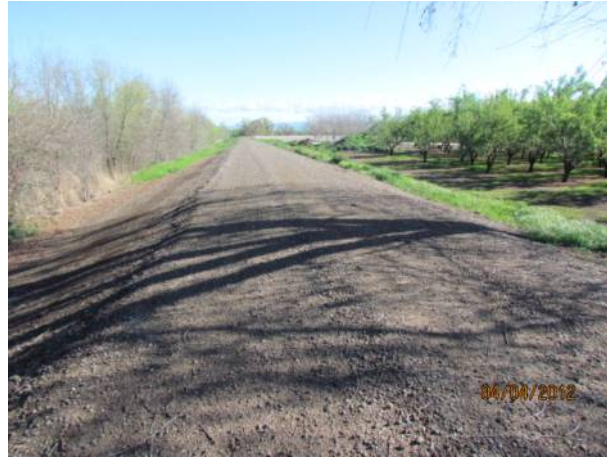
Levee Mile Report Line	1
Start Levee Mile	0.12
End Levee Mile	0.12
Location	Land Side
Category	Earthen Levee
Item	Vegetation

LMR No.	Levee Mile		Category	Item	Location *	Rating **	Action/Comment	GPS Latitude/Longitude		Issue No.
	Start	End						Start	End	
1	0.12	0.12	Earthen Levee	Vegetation	LS	A	V1 : Control annual grass and weeds on the levee slopes and easements.	39.733828 ° -121.929705 °	39.733828 ° -121.929705 °	3 Y

View of the grasses on both slopes.

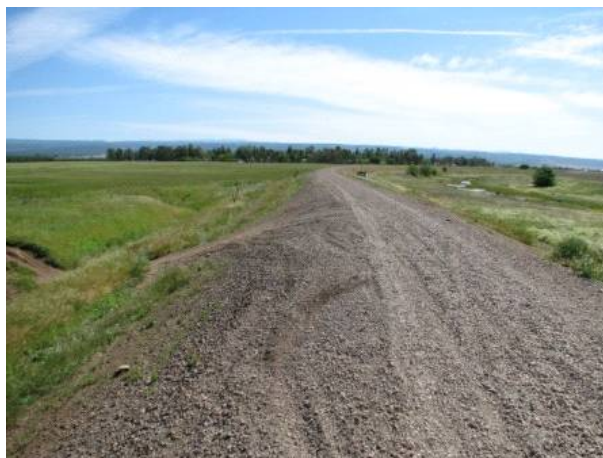
Levee Mile Report Line	1
Start Levee Mile	0.06
End Levee Mile	0.06
Location	Water Side
Category	Earthen Levee
Item	Slope Stability

LMR No.	Levee Mile		Category	Item	Location *	Rating ** +	Action/Comment	GPS Latitude/Longitude		Issue No. Photo
	Start	End						Start	End	
1	0.06	0.06	Earthen Levee	Slope Stability	WS	M Ma	S3 : Repair the levee slope damaged by vehicle traffic and prevent access where possible.	39.786068 ° -121.881828 °	39.786068 ° -121.881828 °	3 Y
DWR ID: DWR_NA0003_03_s_2012_3										
2	0.13	0.13	Earthen Levee	Vegetation	LS	A Ma	V1 : Control annual grass and weeds on the levee slopes and easements.	39.786392 ° -121.880392 °	39.786392 ° -121.880392 °	4 Y
DWR ID: DWR_NA0003_03_s_2012_4

View of the motorcycle erosion on the landside slope of the levee.

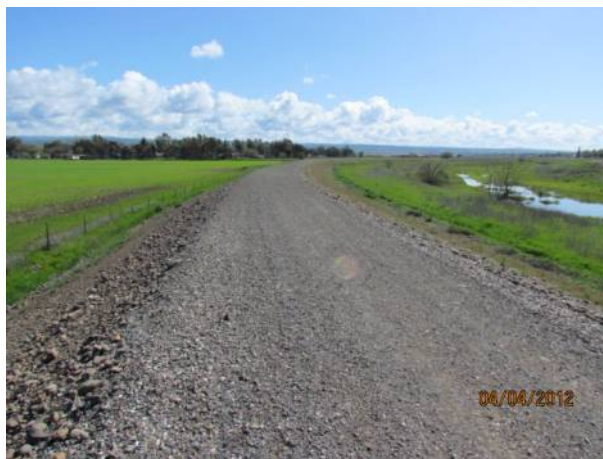
Levee Mile Report Line	2
Start Levee Mile	0.13
End Levee Mile	0.13
Location	Land Side
Category	Earthen Levee
Item	Vegetation

View of the grasses on both slopes.

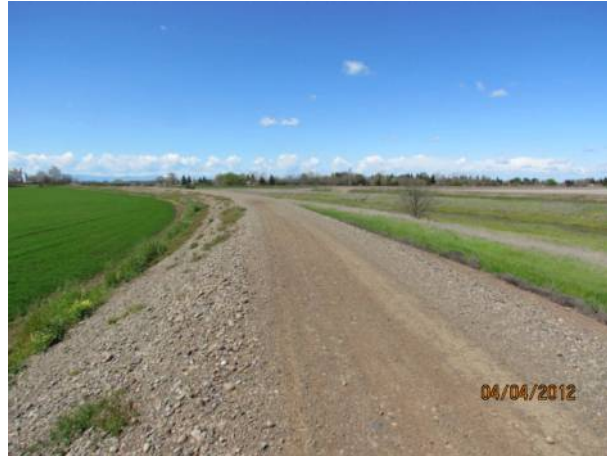
Levee Mile Report Line	4
Start Levee Mile	2.72
End Levee Mile	2.72
Location	Land Side
Category	Earthen Levee
Item	Vegetation

View of the grass on both slopes.

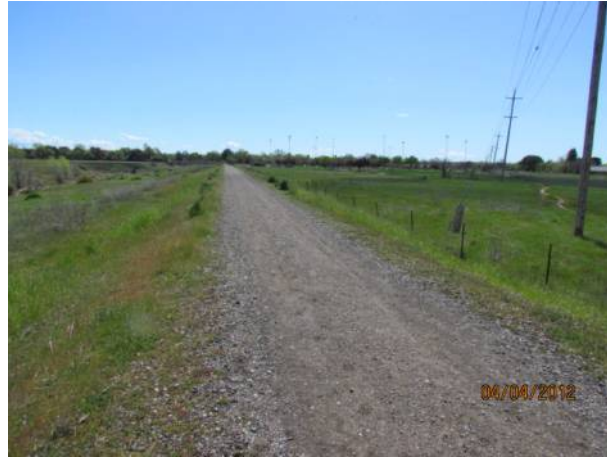
View of the native grasses on both slopes.
